## Failure mechanism of blast furnace tuyeres

Natasa Vuckovic-Spitzer, Institute of Metallurgy, Clausthal University of Technology, Germany

**Key Words:** blast furnace, tuyeres, failure mechanism, copper corrosion

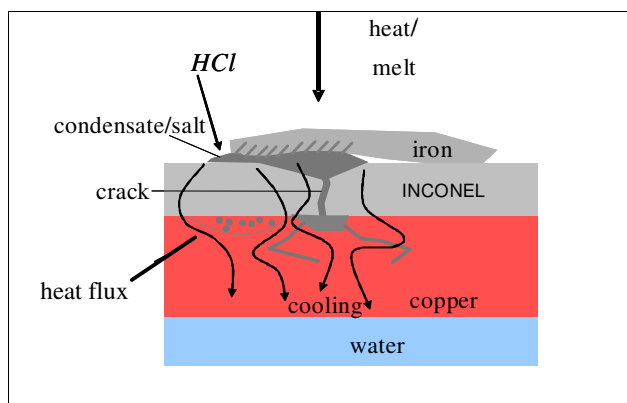
Figure 1: Schematic illustration of the tuyere failure mechanism

The tuyere failure begins with formation of a corrosive electrolyte (e.g.,  $\text{HCl}$  dissolved in water condensate) in the gap between the tuyere surface and solidified iron droplet (Fig. 1). This acidic and corrosive solution attacks first the INCONEL 625® coating on the tuyere forming a channel which propagates to the copper. Cracks formed in the INCONEL 625® layer during the coating operation facilitate this process.

The corrosion process continues in the copper. The electrolyte reacts with impurities such as sulphides and oxides deposited at the grain boundaries forming the intergranular cracks. It is also possible that diffusion of the gases (e.g., hydrogen and/or chlorine) through the copper and their interaction with fine dispersed oxide and sulphide precipitates results in the formation of the micropores. The cracks and microporosity formed in the copper cause a significant decrease in copper thermal conductivity and deteriorate copper cooling within these regions. Due to continuous splashing of the hot iron and slag on the tuyere surface, the temperature of the copper rises, exceeds its melting point and local melting of the copper occurs. The liquid iron propagates through the tuyere wall reducing its thickness. Under certain thermal conditions a pocket of the steam can be formed on the inner tuyere wall. Simultaneously, the corrosion proceeds further through the solidified iron and copper.

The effects of permanent thermal load from above and reduced heat transfer due to steam beneath finally cause the rupture of the tuyere and the water flow into the furnace.

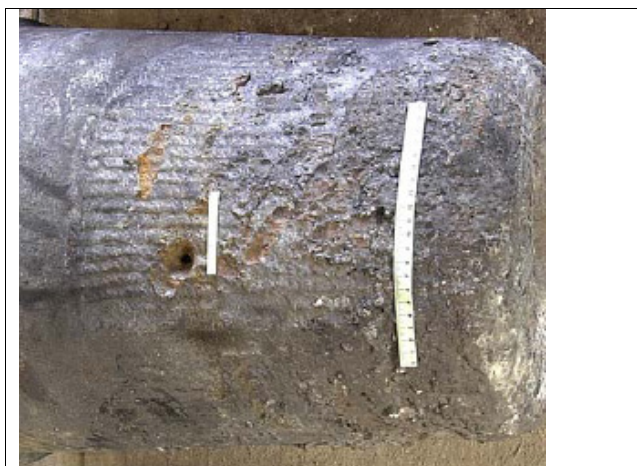
Observation of the destroyed blast furnace tuyeres showed that the failure areas are mostly located on the tip part of the tuyeres which is directly exposed to the furnace interior. In the majority of cases the defect areas are in the form of holes propagating through the tuyere wall and have a size of up to a few centimetres. (Fig. 2).

Figure 2: A tuyere showing defect in the form of small holes on its front part

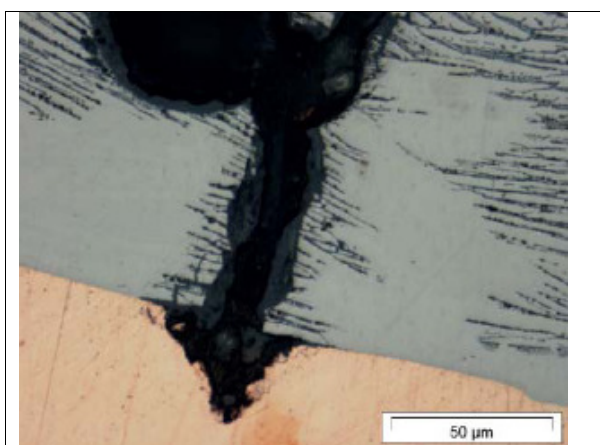
The samples cut from the failure areas of destroyed tuyeres were metallographically examined (optical microscopy and scanning electron microscopy (SEM/EDX)). Also, elemental mapping was used to determine distribution and concentrations of the certain elements over the failure areas of tuyeres. Microscopic observations showed a few typical microstructure features of the destroyed regions: the presence of a layer of iron tightly adhering to copper, presence of channels, holes and copper inclusions in the iron as well as the presence of different defects in the copper in the vicinity of the copper/iron interface. The iron layer adhering to the copper consists of two sublayers: the first iron sublayer formed directly on the copper due to intensive cooling contains carbon chemically bonded to iron carbide (cementite,  $\text{Fe}_3\text{C}$ ), while the second one, more distant from the copper/iron interface shows the presence of dispersed graphite flakes. The channels extending through the iron layer to the copper are most probably intersections of the cutting plane with the cracks present in the samples. They are partially filled with a grey phase and create sometimes cavities in the tuyere copper (Fig. 3).

Figure 3: A channel extending through the iron layer to the copper

It seems that such cavities with rough walls are formed during a corrosion process in which the copper is dissolved and transported away with an electrolyte through the channel. As the corrosion process in the tuyere copper propagates, the cavities initiated at the copper/iron interface grow and may become as large as the one shown in Figure 4.

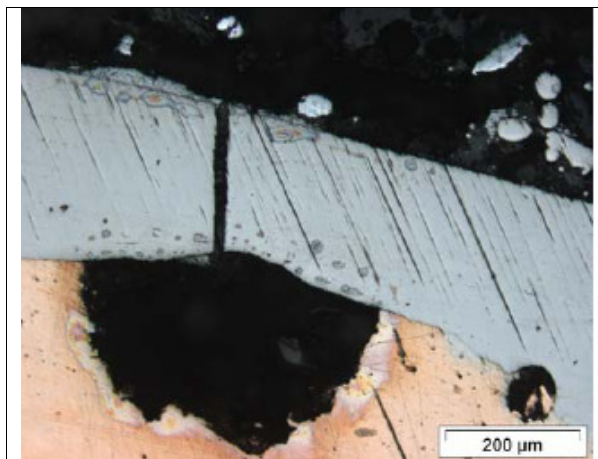
Figure 4: A large cavity in the tuyere copper

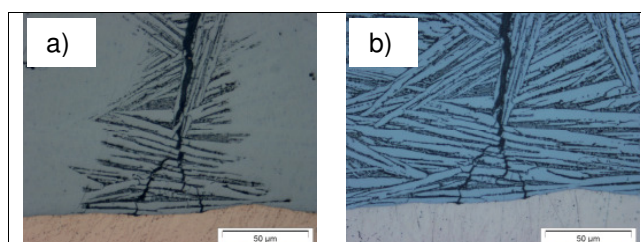
The needle-like structure of the iron visible in the surrounding of the channels is the result of an electrochemical reaction occurring between an electrolyte and the ferrite as less noble micro-constituent of iron [14]. The areas of corroded ferrite appear dark on the micrographs, while the more noble cementite appears as bright elongated grains (needles). This assumption was confirmed by metallographic observation of a tuyere sample exhibiting the needle-like structure in the surrounding of a channel in polished condition (Fig. 5a).

Figure 5: Iron microstructure in the surrounding of a channel: a) polished b) etched with 3%  $\text{HNO}_3$

After etching with  $\text{HNO}_3$ , the needle-like structure became visible over the whole iron surface due to the reaction between  $\text{HNO}_3$  and ferrite (Fig. 5b). By subsequent polishing, the surface layer was removed and the needle-like structure of the iron was again visible only around the channel as shown in Figure 5a. This indicates that the iron revealing the needle-

like structure on the polished sample surface was already attacked with some electrolyte transported here through the channel (the crack in three-dimensions). The reaction between the electrolyte and ferrite in the iron occurred in the space surrounding the channel. The needle-like structure originated from this reaction can not be removed by polishing because it extends to some depth under the sample surface in the region adjacent to the crack. Another sign of corrosion in the samples of destroyed tuyeres are very small copper particles (from a few  $\mu\text{m}$  to tents of  $\mu\text{m}$  diameter) that have been discovered in the regions of dissolved ferrite in the iron layer. This copper could be brought there with some electrolyte in the form of copper ions and thereafter precipitated as metallic copper by cementation with ferrite.

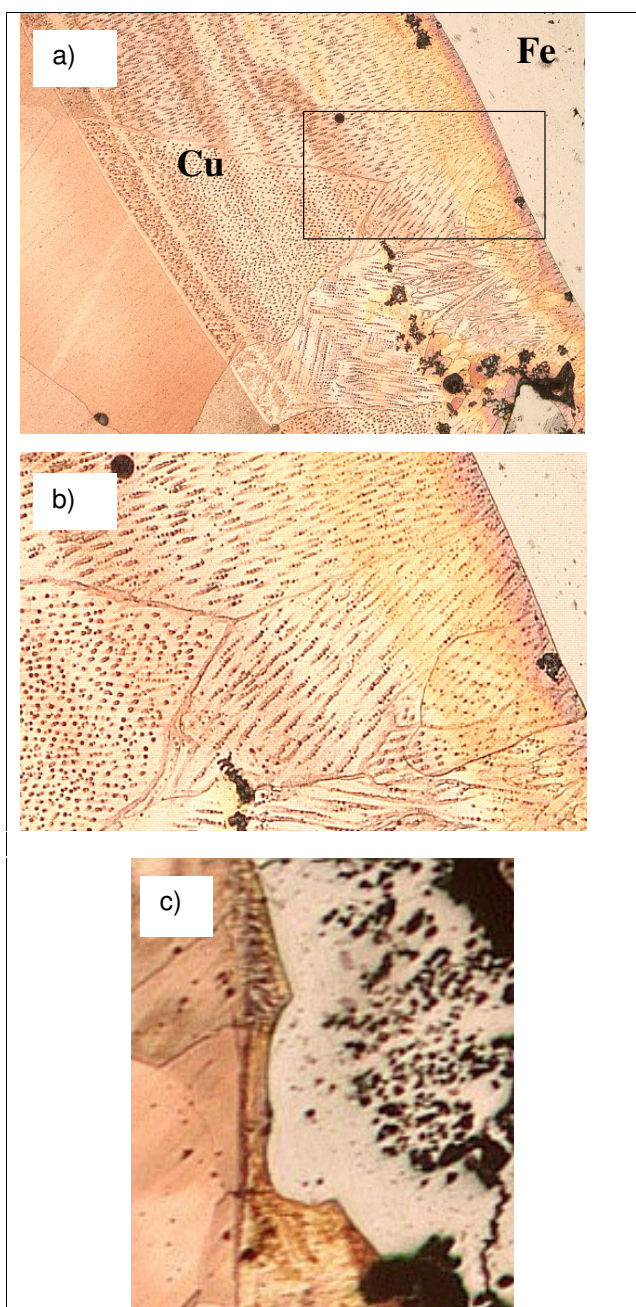
Optical photomicrograph presented in Figure 8a reveals copper microporosity in a zone extending parallel to the interface copper/iron. The area of porous copper marked by the rectangle in Figure 8a is shown enlarged in Figure 8b. As can be seen in Figure 8b, the copper porosity spreads across the entire copper grains and exhibits orientation depending on the crystal grain orientation. The porosity can be attributed to a chemical reaction, which occurred between diffusing species (e.g. hydrogen and/or chlorine) and small precipitates (e.g. oxides and sulphides) dispersed along dislocations lines in copper. Figure 8c shows progress of local melting into the zone of porous copper induced by molten iron. The dark areas visible in the iron layer indicate the occurrence of corrosion.

Figure 8: Microporosity in tuyere copper

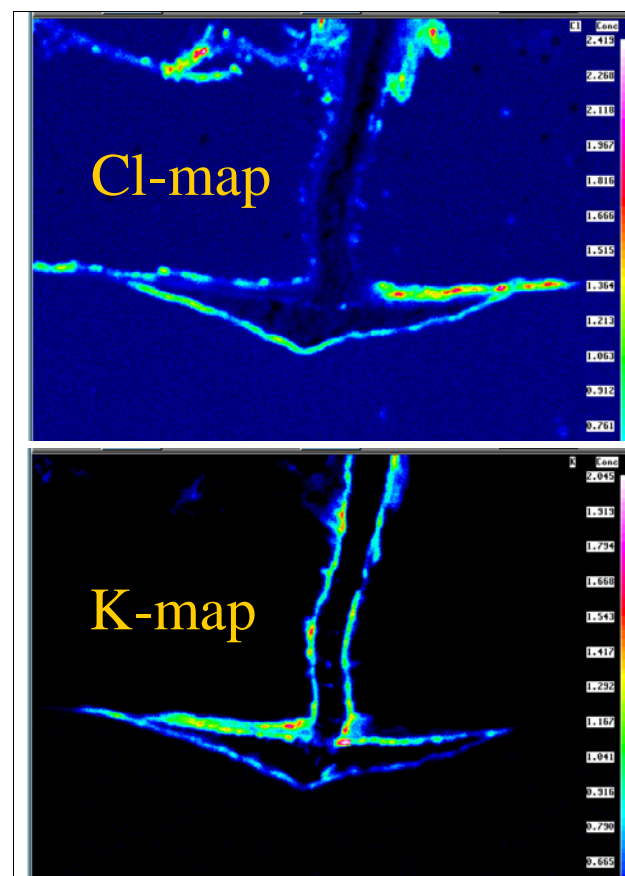
The important role of chlorine in the failure mechanism of tuyeres was confirmed by ESMA analysis of a sample of a destroyed tuyere. The mapping area was chosen to include a channel going through the iron layer and forming a cavity at the copper/iron interface. Mappings of the elemental distribution were done for Cu, Fe, Si, S, Cl, Zn, K and Na. Chlorine and alkalis showed similar distribution within the analyzed area. They are mostly present on the channel wall and at the edges of the cavity in the copper as show the elemental maps for chlorine and potassium (Fig. 9). The coincidence of the distributions of K, Na and Cl indicates the presence of KCl and NaCl. But there are some areas in the chlorine map (the upper left corner of the chlorine

map and the interface copper/iron) where a high observed chlorine concentration (1.8 – 2.3 wt. %) is not correlated with especially high concentrations of alkalis. It seems that chlorine has higher mobility than the alkali metals in the attacked regions of tuyeres, which can be explained by simultaneous chloride transport by both metal chlorides and HCl, whereby the latter one spreads more easily.

Figure 9: Elemental maps of Cl and K in a failure site

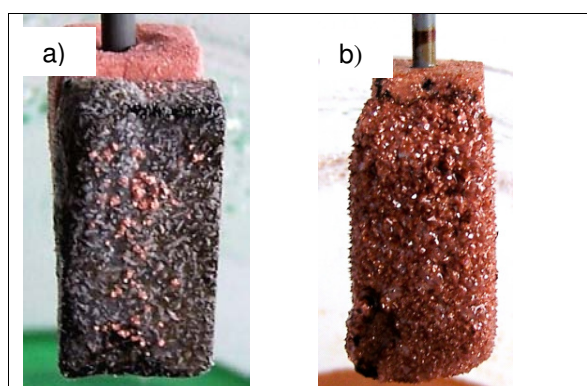
member of the galvanic couple, the Armco iron corrodes providing cathodic protection to the copper. The galvanic couple consisting of tuyere copper and rapidly solidified iron exhibited quite different dissolution behaviour in HCl solution. During the first 8 days of immersion, except for the initial dissolution of the surface oxide film, the copper piece did not show any observable changes in the appearance. Simultaneously an intensive formation of the hydrogen bubbles on the iron indicated the dissolution of its ferrite phase. However, after this period, a rapid dissolution of the copper began which was observed by the diminution of the copper piece size and subsequent copper deposition from the solution onto the surface of the iron piece in the form of fine particles (Fig. 10). After 15 days the experiment had to be stopped due to breakdown of the welded joint. At that moment the whole surface of the iron piece was covered with fine copper particles (Fig. 10b).

Figure 10: Deposition of copper from HCl solution on the cementite-rich iron: a) after 12 days and b) after 15 days of immersion

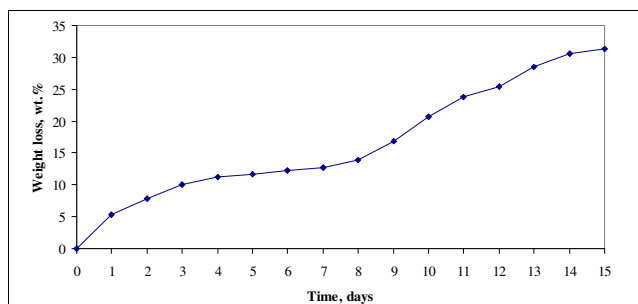
This visual observation of the tuyere copper-rapidly solidified pig iron couple is in accordance with its weight loss-time curve presented in Figure 11, where a significant increase in the weight loss after 8 days indicates the initiation of the copper dissolution. Thus, the dissolution curve can be divided into two stages. The first stage corresponds to the ferrite dissolution from the rapidly solidified iron. The second stage beginning around the eighth day of immersion involves an intensive copper dissolution, even though a considerable amount of copper precipitates again from the solution on the iron part of the sample.

Figure 11: Weight loss-time curve for the couple consisting of tuyere copper and rapidly solidified iron in 0.5M HCl
